# Rudder repair

By Tom Pawlak of West System Inc.

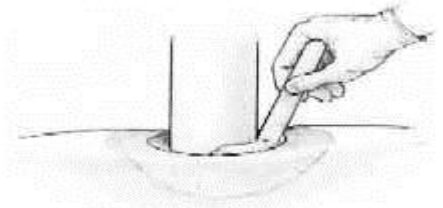
As a rudder ages and additional fatigue cycles accumulate, stress cracks may develop in the fibreglass laminate around the rudder post at the top of the rudder. These cracks usually radiate from the post into the surrounding fibreglass, often beginning at the glue joint where the two fibreglass halves of the rudder meet. If the cracks are limited to this glue joint, they can be cleaned out with a broken hack saw blade or rotary grinder and glued back together with epoxy thickened with high density filler.

If the cracks at the top of the rudder radiate into fibreglass beyond the glue joint, the cracks need to be properly repaired. This is accomplished by grinding out all of the damaged fibreglass and replacing the removed material with fibreglass cloth and WEST SYSTEM® Epoxy. At the same time, reinforce the joint between the rudder post and the fibreglass rudder top by cutting away a band of fibreglass and core around the post and filling the gap with epoxy thickened with high density filler.

1. Grind away the damaged fibreglass skin around the cracks with a rotary tool like a die grinder or Dremmel™ tool. Avoid grinding into the rudder post, this will weaken it. Cut the opening to a smooth circular or oval shape, and grind a 12:1 bevel around the edge of the fibreglass.

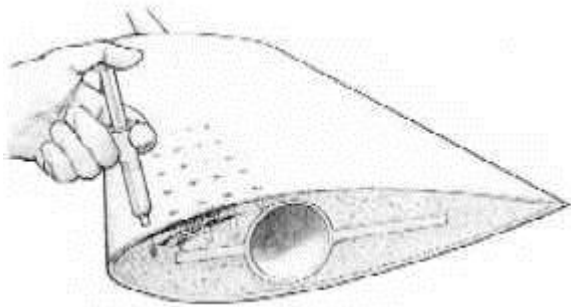
Delamination can occur anywhere in the rudder but will most likely show up in this same area where the metal mandrel inside the rudder ends. The stress cracks and delamination can go unnoticed for a season or two and the problem may not be identified until water begins weeping from the rudder after the boat is pulled from the water.

1. Drill a series of 1/8" to 3/16" holes on a one inch grid pattern over the debonded area. Drill deep enough to get to the centre of the core. You may hit the metal mandrel.
2. Dry the core. Wet cores can take weeks or months to dry even if a multitude of holes have been drilled. Force drying with heaters or heat lamps is recommended for speeding the process.

3. Verify that the core is dry by drilling a few more holes when you think the rudder has dried out. Squeeze the core drillings to see if they are dry.
4. Inject a slow curing epoxy such as 105 Resin and 206 Hardener or 105 Resin with 209 Extra Slow Hardener. Use syringes to force the epoxy into the delaminated areas. Lay the rudder on its side with the drilled side facing up, so gravity works in your favour.
5. Refill the holes as necessary with unthickened epoxy until the holes are filled flush with the surface. A light layer of fibreglass cloth can be applied over the area to strengthen the area if desired.
