# Rudder repair

By Tom Pawlak of West System Inc.

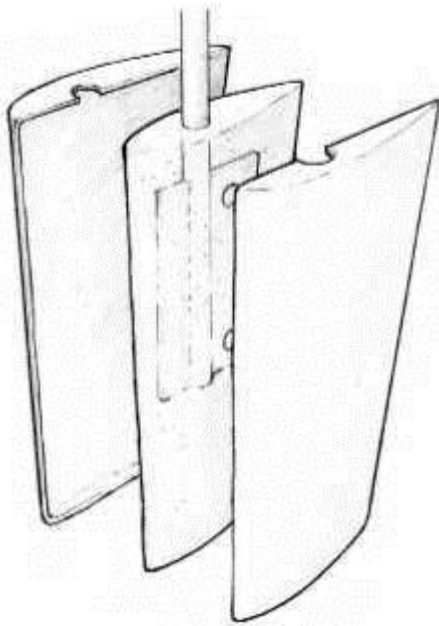
A typical spade rudder for sailboats is made up of two fibreglass skins that define the shape of the rudder, a metal mandrel that is an extension of the rudder post, and foam core which bridges the space between the skins and mandrel. In order for a rudder like this to work properly, its fibreglass skins must be attached to the core and the core must be attached to the metal mandrel. Side loads on a rudder exert compression loads on the core which transfer into the mandrel. If the components become detached, the rudder can deflect excessively and eventually develop cracks in the fibreglass skins.
